# Manhole Inspection Summary

Manhole # S35S\_\_057MH

Insp Date: **1/29/08 10:06 AM**

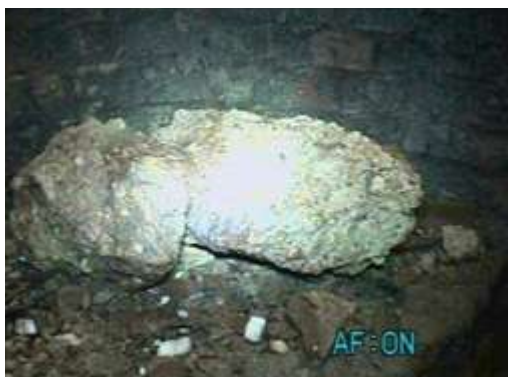
Defect 1

Condition: ☐ Sound ☐ Cracked ☐ Root Intrusion ☐ Deteriorated ☐ Leaks ☒ **Debris**

bench debris

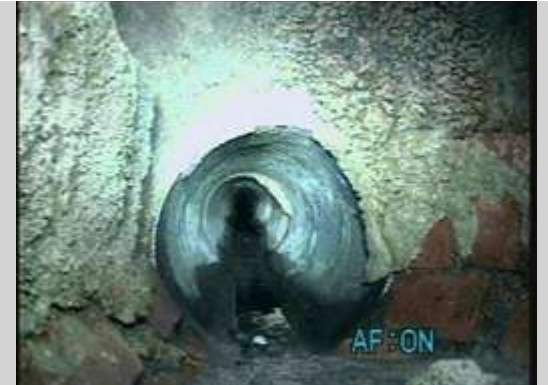
12 O'Clock Outflow

8 in. Circular Gravity Sewer  
Pipe Out @ 12 O'Clock

Pipe Material: **Clay** ☐ Pipe Lined

Invert Depth: **9.60** (ft.) Flow Characteristics: **Slow**

Deposits: ☒ None ☐ Mud ☐ Sludge ☐ Debris ☐ Grease

Infiltration: **None** Pipe Seal Cond: **Unknown**

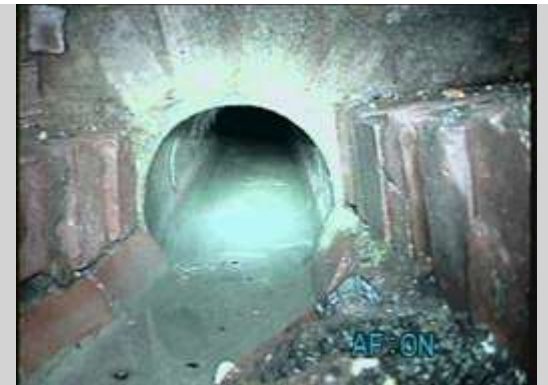
3 O'Clock Inflow

8 in. Circular Gravity Sewer  
Pipe In @ 3 O'Clock

Pipe Material: **Clay** ☐ Pipe Lined

Invert Depth: **9.50** (ft.) Flow Characteristics: **Slow**

Deposits: ☒ None ☐ Mud ☐ Sludge ☐ Debris ☐ Grease

Infiltration: **None** Pipe Seal Cond: **Unknown**

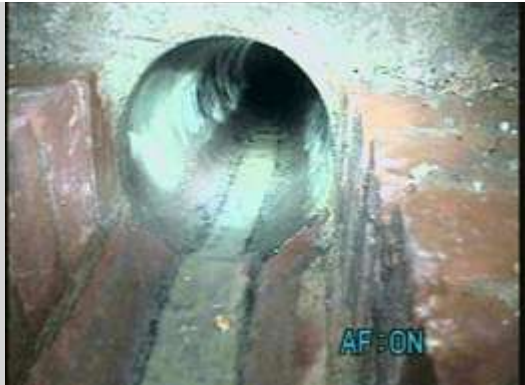
6 O'Clock Inflow

6 in. Circular Gravity Sewer  
Pipe In @ 6 O'Clock

Pipe Material: Clay ☐ Pipe Lined

Invert Depth: 9.20 (ft.) Flow Characteristics: None

Deposits: ☒ None ☐ Mud ☐ Sludge ☐ Debris ☐ Grease

Infiltration: None
